Manhole Inspection Summary

Manhole # S21KK_029MH

Insp Date: **6/1/07 8:41 AM**

Location Address: **1937 FULTON AVE**

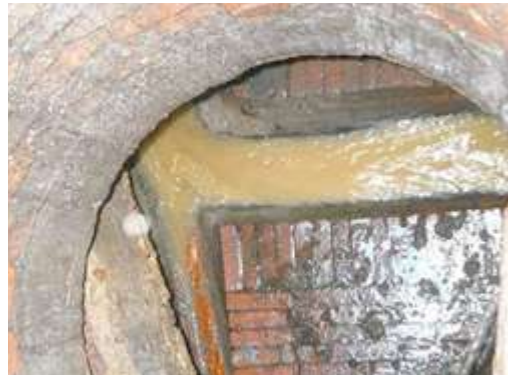
Top View

Comments **RETOOK TOP VIEW PHOTO AS REQUESTED - 3-4-09**

BEST VIEW FROM TOP POSSIBLE

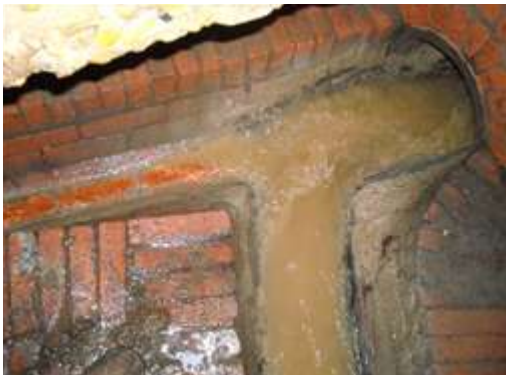
INSIDE TOP VIEW

3 OCLOCK IS COMING FROM BOTTOM, THIS IS WHAT IS PARTIALLY VISIBLE IN TOP SHOT

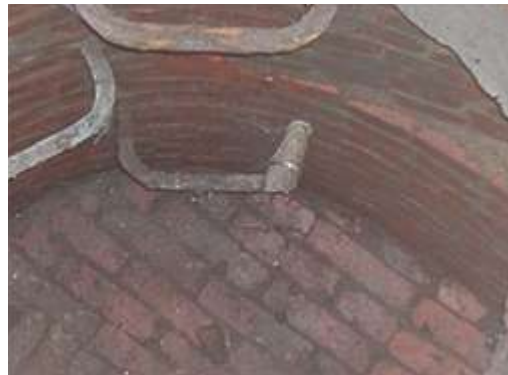
Defect 3

☒ **Evidence Of Surcharge** Depth: **2** (ft.) ☐ Active Surcharge Present

SURCHARGE EVIDENCE ON STEPS

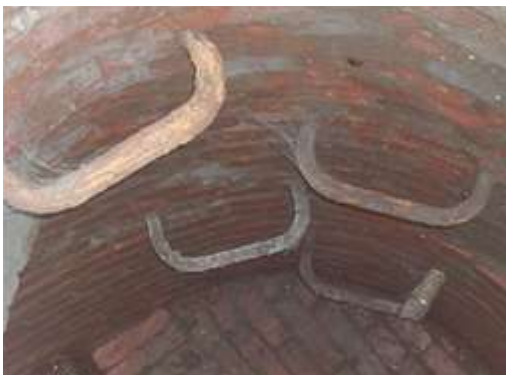
Defect 2

Count: **5** Missing: **0** ☒ **Corroded**

CORRODED STEPS

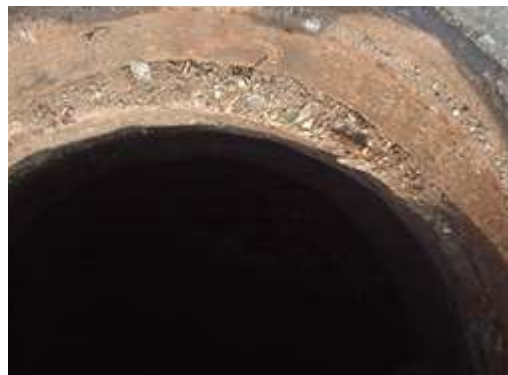
Defect 1

Offset: **2** (in.)

FRAME OFFSET

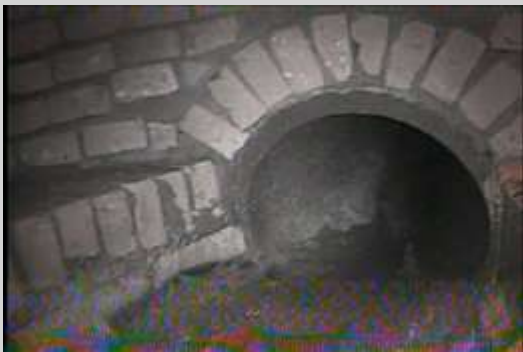
12 O'Clock Outflow

15 in. Circular Gravity Sewer
Pipe Out @ 12 O'Clock

Pipe Height: **14.4** (in.) Rod and Bar (Angled)
Pipe Material: **Clay** ☐ Pipe Lined
Invert Depth: **9.11** (ft.) Flow Characteristics: **Slow**
Deposits: ☒ None ☐ Mud ☐ Sludge ☐ Debris ☐ Grease
Silt Depth: (in.) Deposits Extent:
Infiltration: **None** Pipe Seal Cond: **Sound**

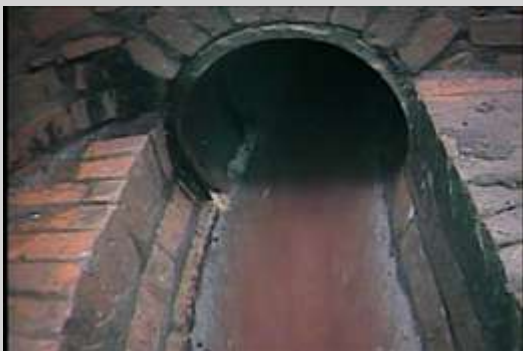
4 O'Clock Inflow

15 in. Circular Gravity Sewer
Pipe In @ 4 O'Clock

Pipe Height: **14.4** (in.) Rod and Bar (Angled)
Pipe Material: **Clay** ☐ Pipe Lined
Invert Depth: **8.99** (ft.) Flow Characteristics: **Slow**
Deposits: ☒ None ☐ Mud ☐ Sludge ☐ Debris ☐ Grease
Silt Depth: (in.) Deposits Extent:
Infiltration: **None** Pipe Seal Cond: **Sound**

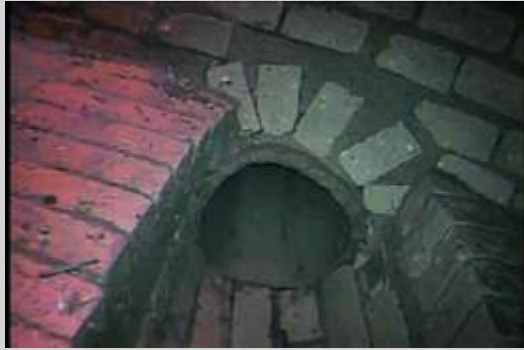
7 O'Clock Inflow

8 in. Circular Gravity Sewer

Pipe In @ 7 O'Clock

Pipe Height: **8.4** (in.) Rod and Bar (Angled)

Infiltration: **None** Pipe Seal Cond: **Sound**
